Study of Lessons Learned from Mangrove/Coastal Ecosystem Restoration Efforts in Aceh since the Tsunami

Bogor, November 2006

After 1.5 years of coastal rehabilitation activity, the results are now clear. Only a small fraction of it has been successful, the rest has failed. This can be seen simply from the low survival rate of plants in the field. Reasons given for the failures include: mistakes in the selection of planting sites, unsuitable choice of plants, insufficient preparation, inadequate guidance, no tending of the plants, and the low capacity of human resources.

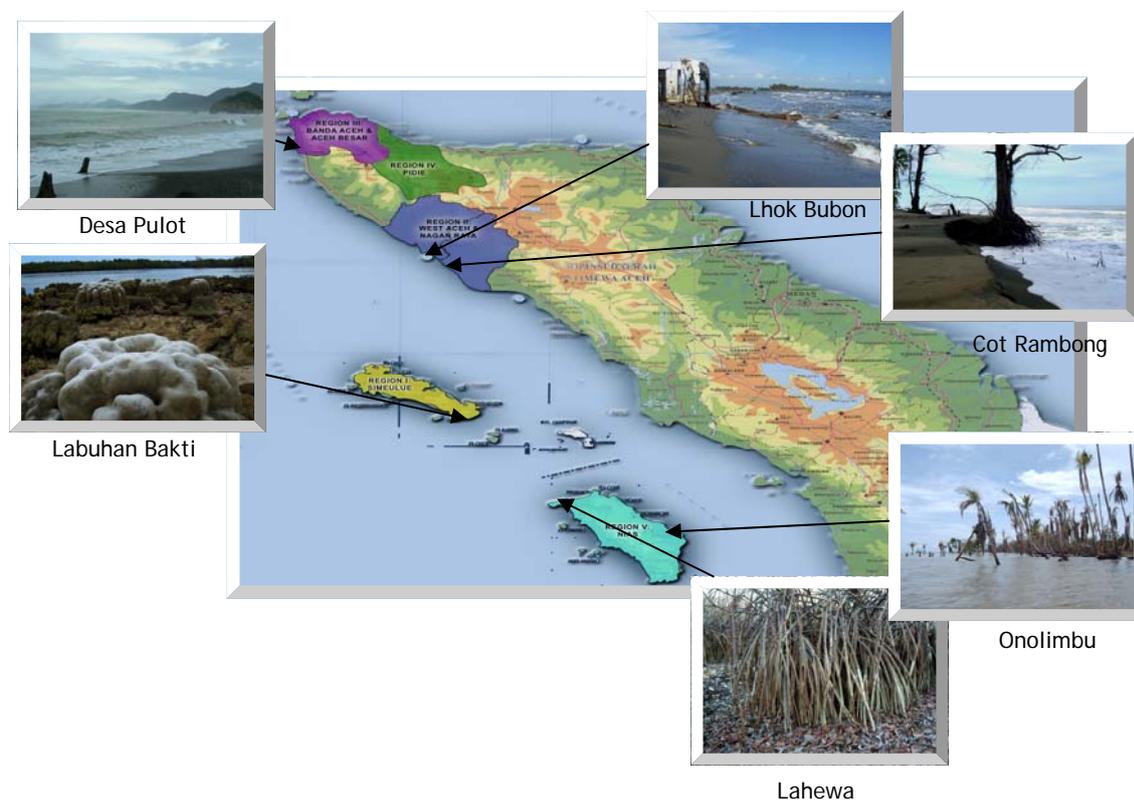
subsidence causing the shoreline to advance 100 to 200 meters inland. On Simeulue island, in contrast, part of the land was lifted up by 2 meters, thereby exposing the coral reef and killing the mangrove forest. The same happened in the north part of Nias island, causing similar damage to the coral reef and mangrove. Nevertheless, not all parts of Nias were lifted up. In the southern part of the island, the land subsided thus causing the shoreline to advance inland by 200 meters. Figure 3-1 below gives a general picture of the landscape change, based on field observations by the WI-IP Team on the west coast of Aceh, Simeulue island and Nias island.

Figure 3-1. Landscape change caused by earthquake and Tsunami along Aceh coast

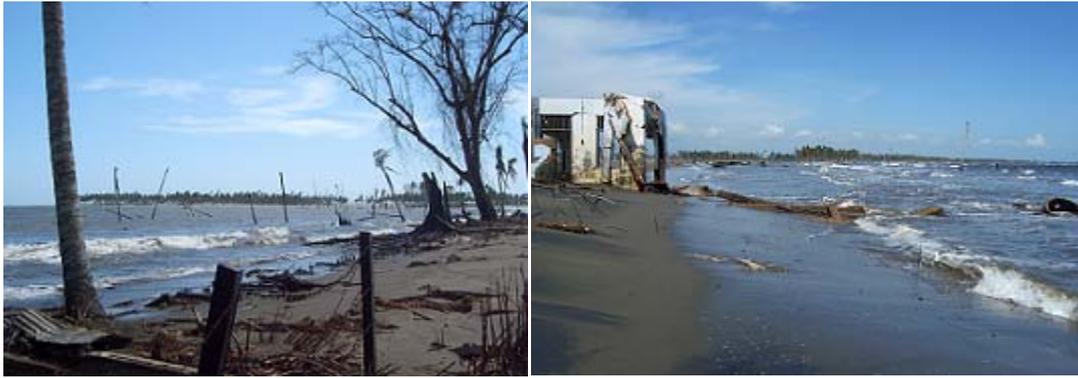
Figure 3-2. Loss of land as a result of earthquake and Tsunami (Lbok Bubon, Aceh Barat)

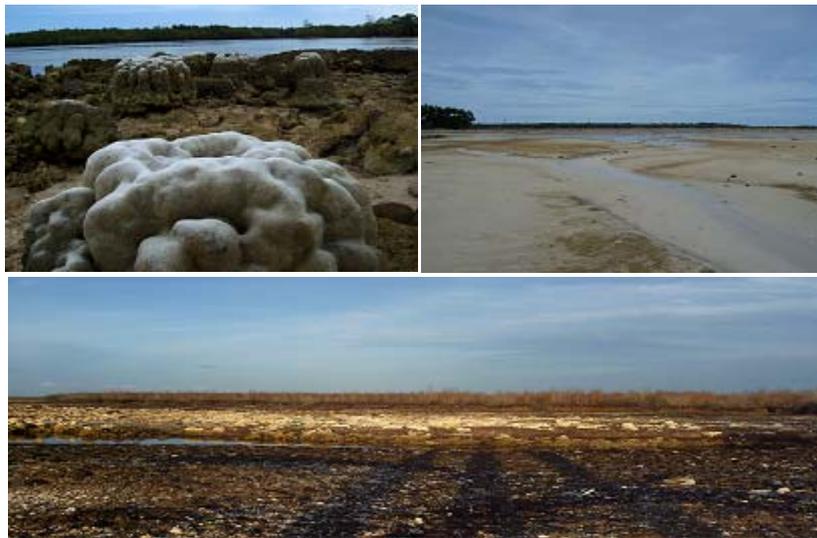
The uplifting of land on Simeulue island and the northern part of Nias island not only exposed the coral reef, causing it to dry out and die, but also had a detrimental impact on the mangrove forest which, now too high above sealevel to be inundated by sea water, also dried out and died (see Figure 3-3 below).

Figure 3-3. Impact of uplifting of substrate: coral reef exposed and dying in Labuhan Bhakti-Simeulue, emergence of new land in Alus-alus- Simeulue, and dried, dead mangrove in Labewa, Nias (clockwise)

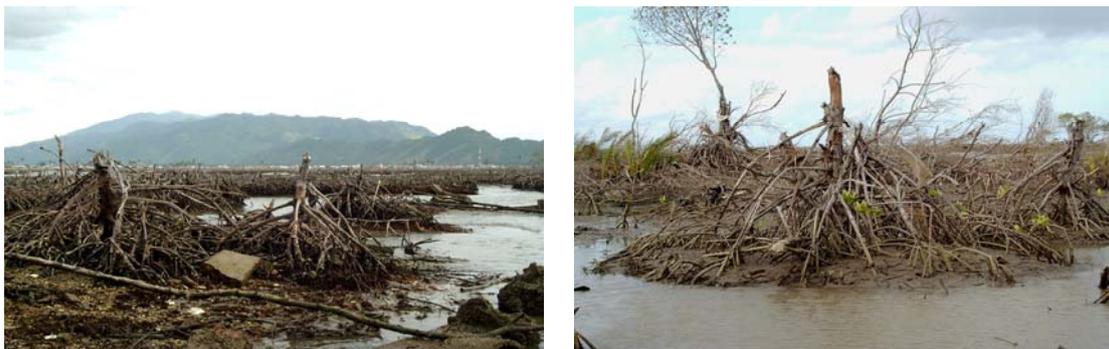
Mangrove forests were one of the types of wetland which suffered the worst damage. This was because, being on the edge of the coast, they were directly hit by the full force of the Tsunami. Towering an average of 10-15 m in height, the Tsunami destroyed the mangrove forests in a matter of seconds. Mangroves were devastated along almost the whole length of Aceh's west coast and part of the east coast.

Figure 3-4. Mangrove forest destroyed by Tsunami in Tibang – Aceh Besar

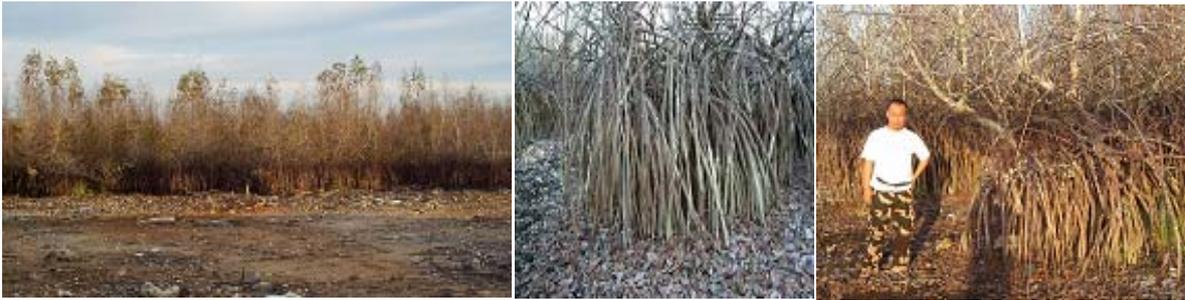
Observation at this site revealed that all *Rhizophora apiculata* trees had become desiccated. All their leaves had fallen, creating a layer of dry litter extending across the floor of the stand. However, on cutting the twigs and branches, it was discovered that the interior parts (xylem, floem) were still moist, indicating that the trees were still alive. The shedding of leaves is most probably the mangrove's response in adapting to the dry conditions through its mechanism of keeping the water balanced. This same leaf-shedding phenomenon also occurs in teak trees during the dry season. If this species of mangrove is capable of adapting to its new environment, then it can be predicted that these stands will survive. If not, they will die. To see how these stands develop, they will need to be monitored continuously and be made the subject of specific research. Amid the dry *Rhizophora* stands, the assessment team found several trees that had survived in spite of the dry conditions. What is interesting is that the species *Ceriops decandra* seemed grows normally without stressed symptom as it happened to *Rhizophora* trees.

Figure 3-6. Mangrove which has desiccated due to uplifting of the substrate at Lahewa village, Nias.

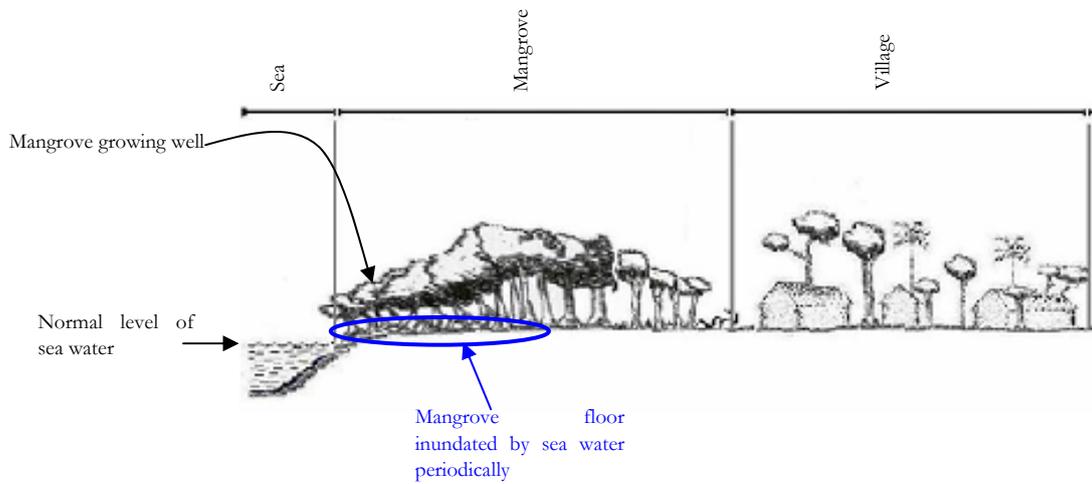
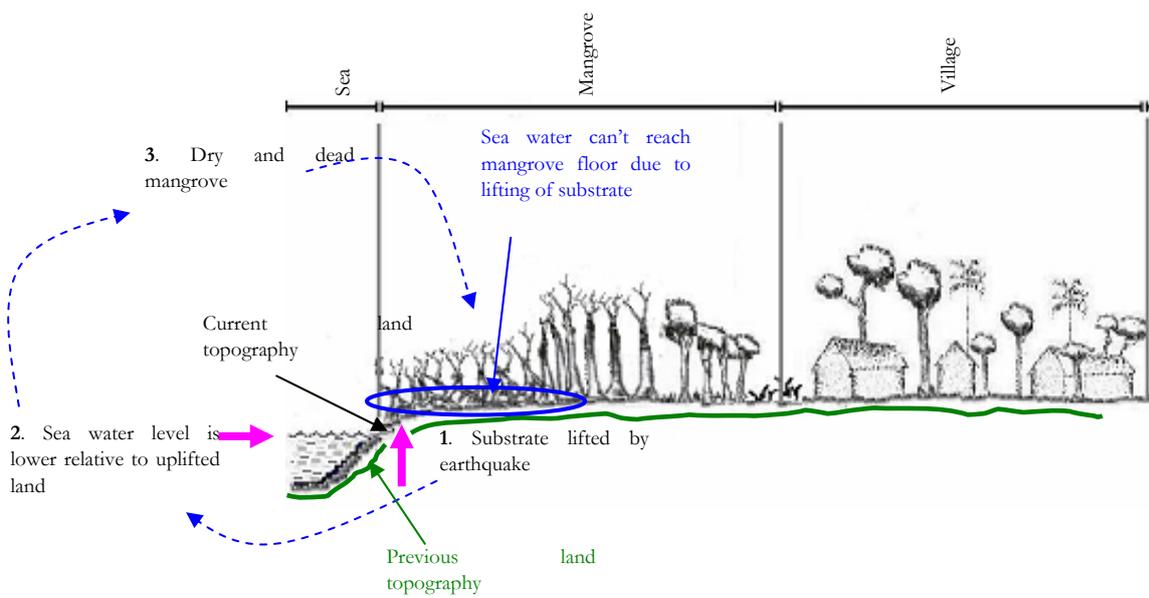
A. Mangrove condition before lifting of substrate

B. Mangrove condition after lifting of substrate

Figure 3-8. Illustration of mangrove death caused by lifting of the substrate at Labewa-Nias

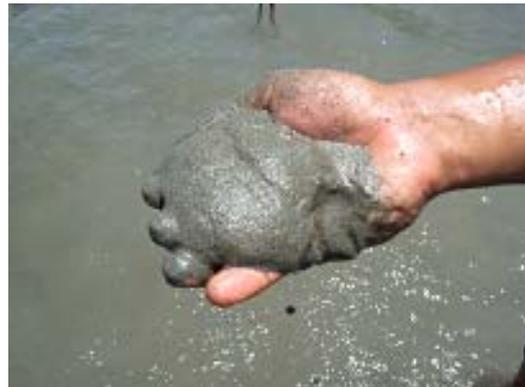
Figure 3-9. *Tsunami deposits on pond floor*

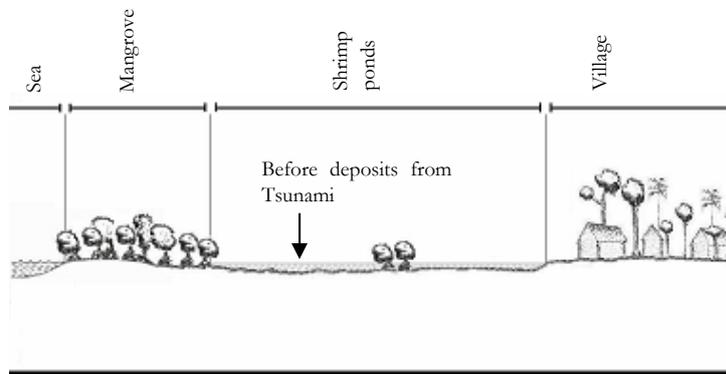
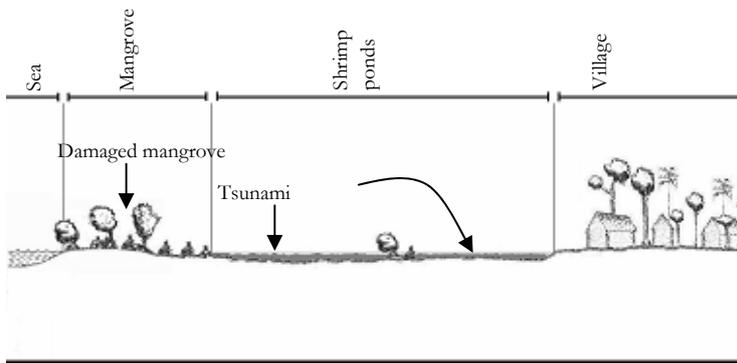
The illustrations in Figure 3-10 below show two different conditions: that before and that after the Tsunami. Diagram B is a cross-section of the condition actually observed in the field, showing the mangrove damage and Tsunami deposits, while diagram A shows the condition before the Tsunami based on field observations enriched with information from the local community.

Figure 3-10. *Condition of aquaculture ponds at Lham Ujong before (top) and after (bottom) the Tsunami*

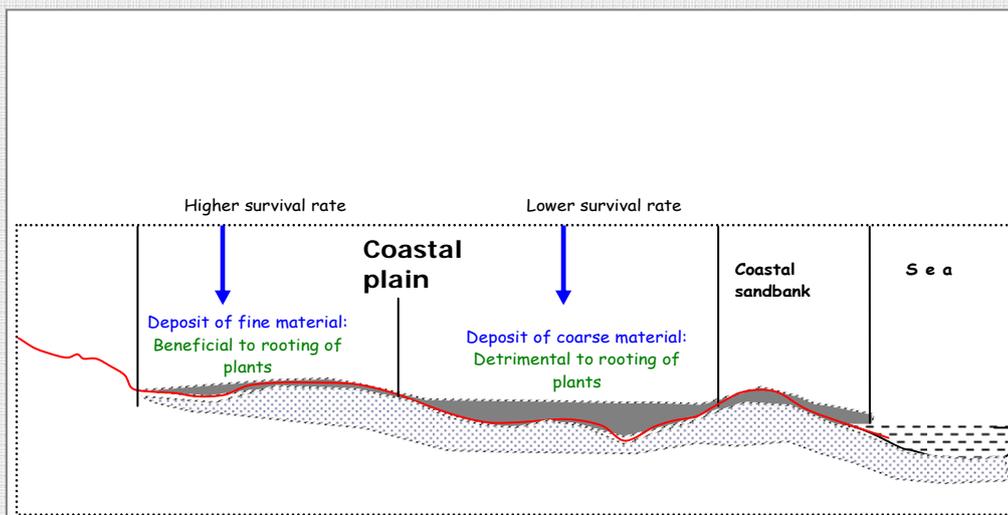
The Tsunami brought material from the sea and deposited it as far as 1 - 2 km inland. In order to determine the impact of this deposit, a case study was carried out by an Assessment Team from Wetlands International in August-September 2005 in the coastal area of Lham Ujong village (Aceh Besar). The study found that coarse material (like sand) had been deposited in locations near the shoreline to a thickness of 20 – 50 cm. This deposit then formed a solid soil structure which caused a decrease in the soil's aeration capability and which transmitted heat easily. Under such conditions, the seedlings' rooting process was seriously obstructed. Meanwhile, finer material (dust and clay) has been deposited further inland. If this material has been deposited on coastal plain to a thickness of less than 20 cm, it will have a more beneficial effect as it will supply additional minerals thus making the soil more fertile. (See Figure 3-11 below).

Figure 3-11. Correlation between location of Tsunami deposit and success of mangrove rehabilitation in Lham Ujong village, Aceh Besar

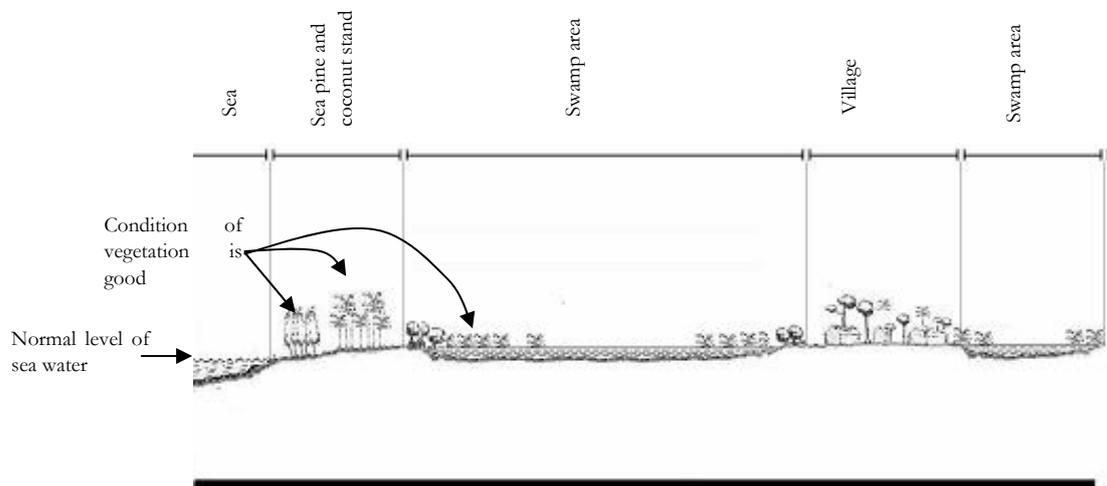
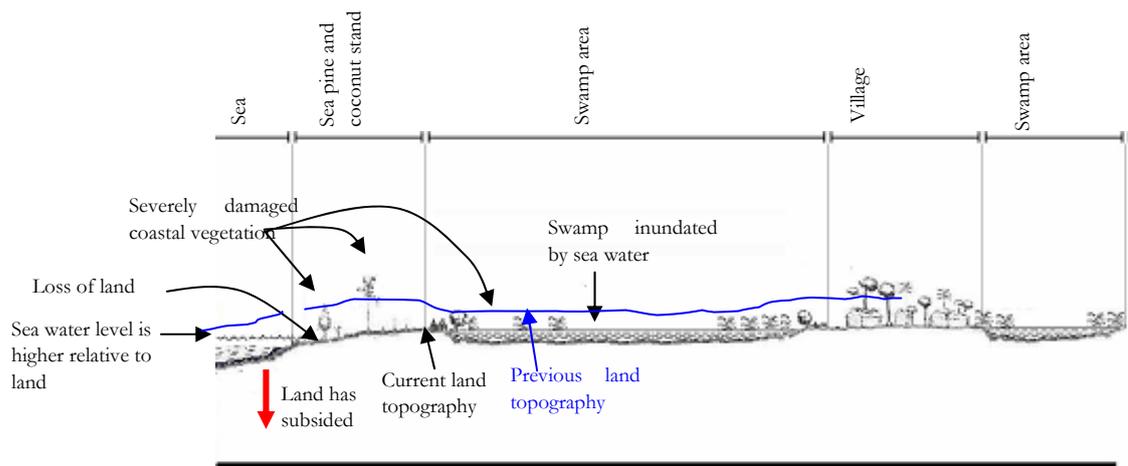
Figure 3-12. Condition of swamp before and after the Tsunami, at Lhok Bubon-Aceh Barat

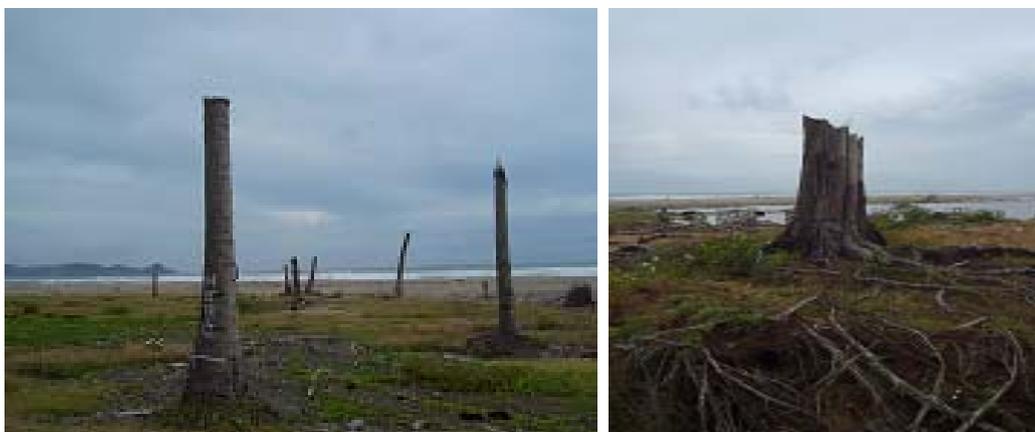
Figure 3-14. *Impact of Tsunami: coconut tree (left) and pine (right) broken, swept by the Tsunami at Lbok N'ga-Aceh Besar*

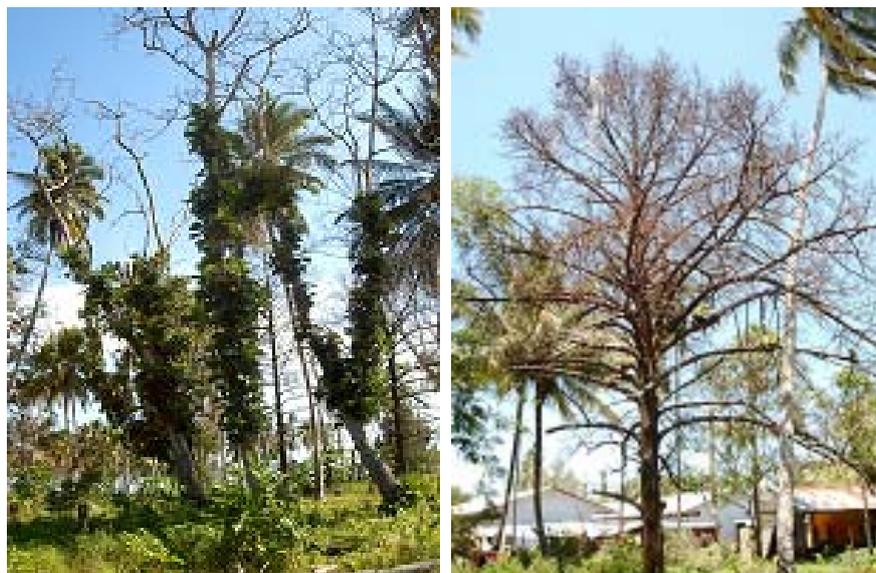
Vegetation along the coast was damaged and killed not only by the direct force of the Tsunami but also as a result of sea water inundation which lasted for several days. In general, it was areas far inland that were inundated.

Figure 3-15. *Effect of sea water: Breadfruit tree alive and healthy (left), Mangosteen tree dead as a result of sea water inundation (right)*

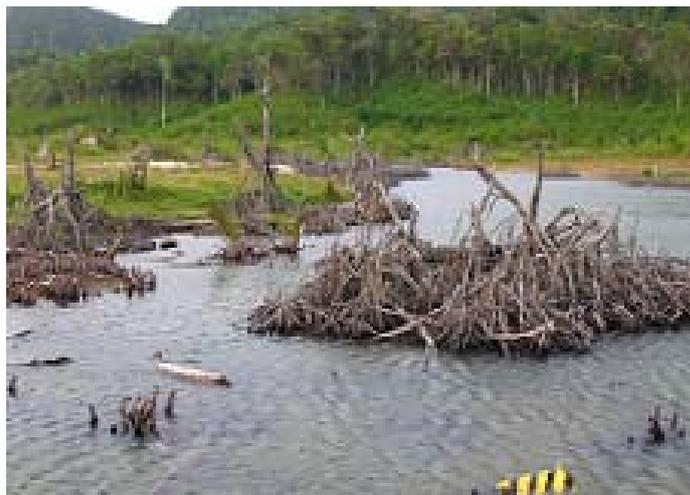
Field observation revealed that the process of recovery through natural regeneration and succession has been much slower and more difficult for mangrove than for other species of coastal vegetation. This is generally because the habitat had been destroyed or drastically altered thus making it unsuitable for mangrove. Changes to the habitat could be due to physical and chemical changes to the substrate or because it was no longer influenced by ocean tides. The mangrove's poor capacity for recovery could also be caused by the loss of all the parent trees, without which there was no possibility of regeneration.

Figure 3-17. Mangrove habitat so badly devastated that mangrove can not recover

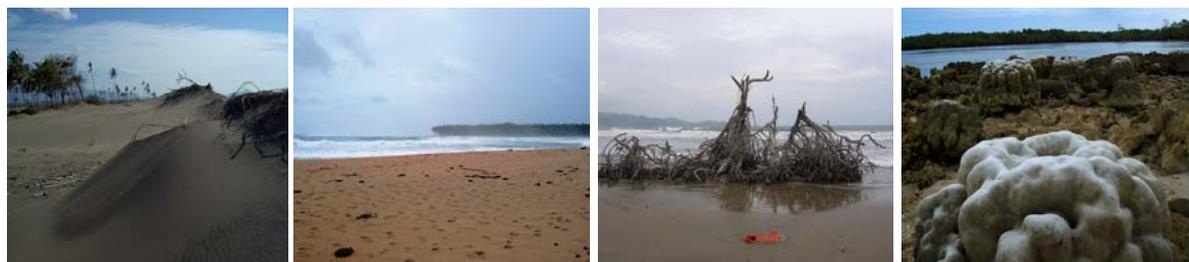
Newly formed land is not fertile. It is usually covered by coral and is highly saline. Moreover, it is usually no longer inundated by sea water, so is not suitable for mangrove. Other species of coastal vegetation will not grow there either, because of the extreme substrate and high salinity.

Figure 3-23. Locations where rehabilitation should be avoided

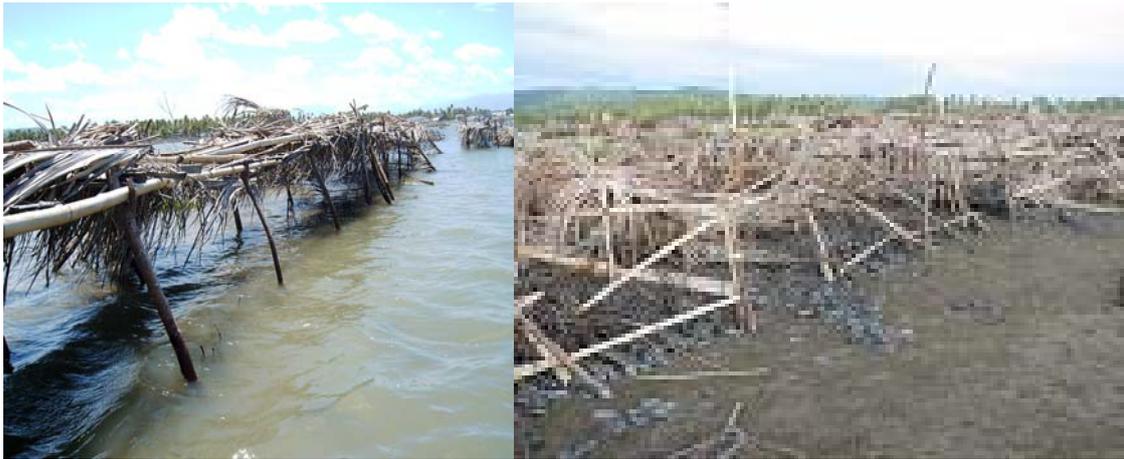
Figure 4-4. Nurseries sited in unsuitable areas: site subject to heavy inundation and strong currents (left); site not subject to inundation (right). Both failed totally. Photographs taken in Lham Nga - Aceh Besar

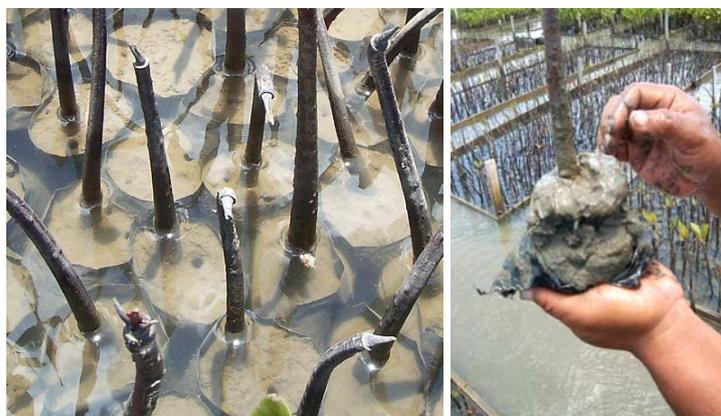
Figure 4-5. Nursery failure due to mistakes in choice of media

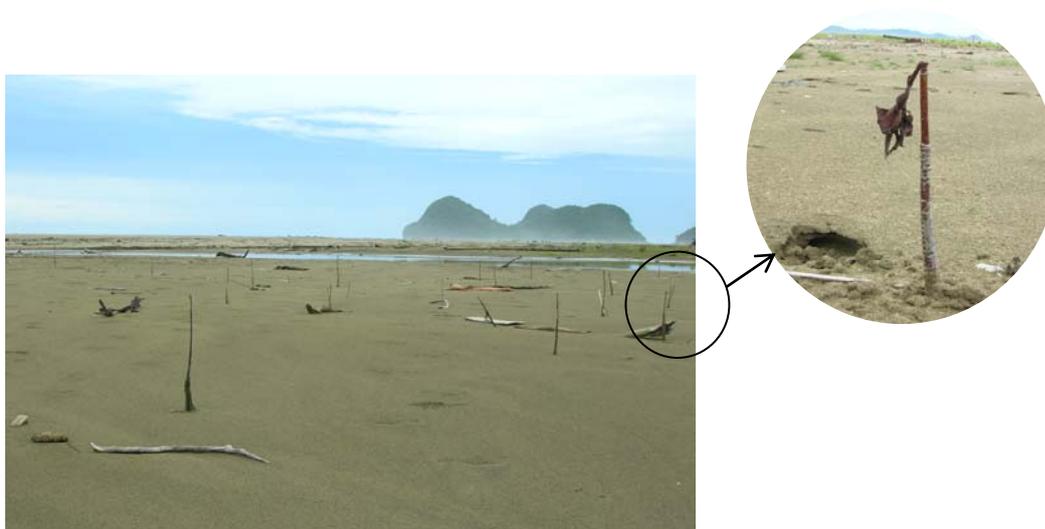
Figure 4-6. Mangrove planted on sandy beach

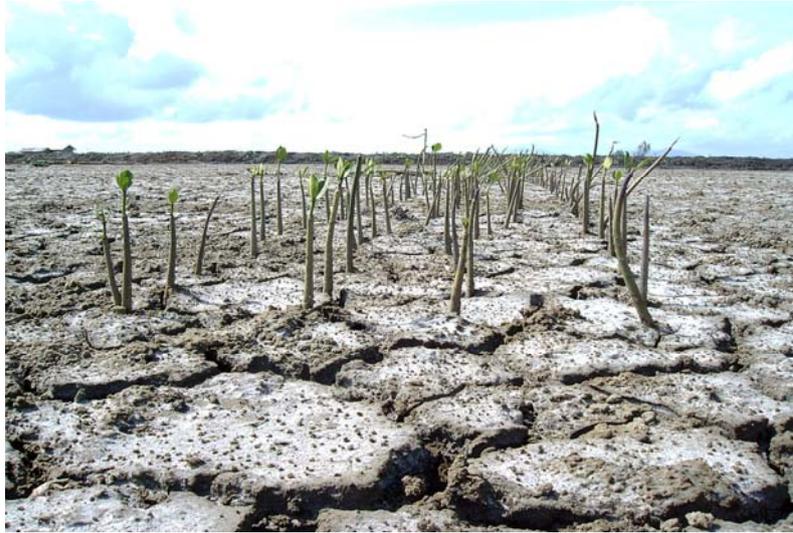
Figure 4-7. Mangrove planted on permanently dry mud

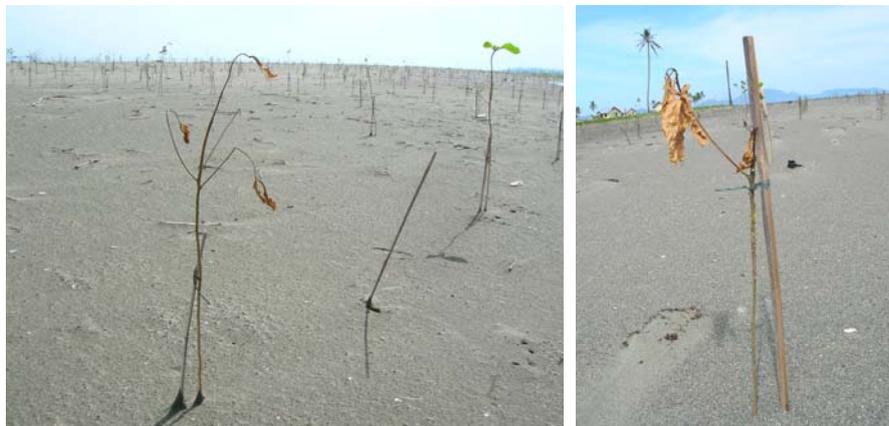
Figure 4-8. Planting on open sandy beach

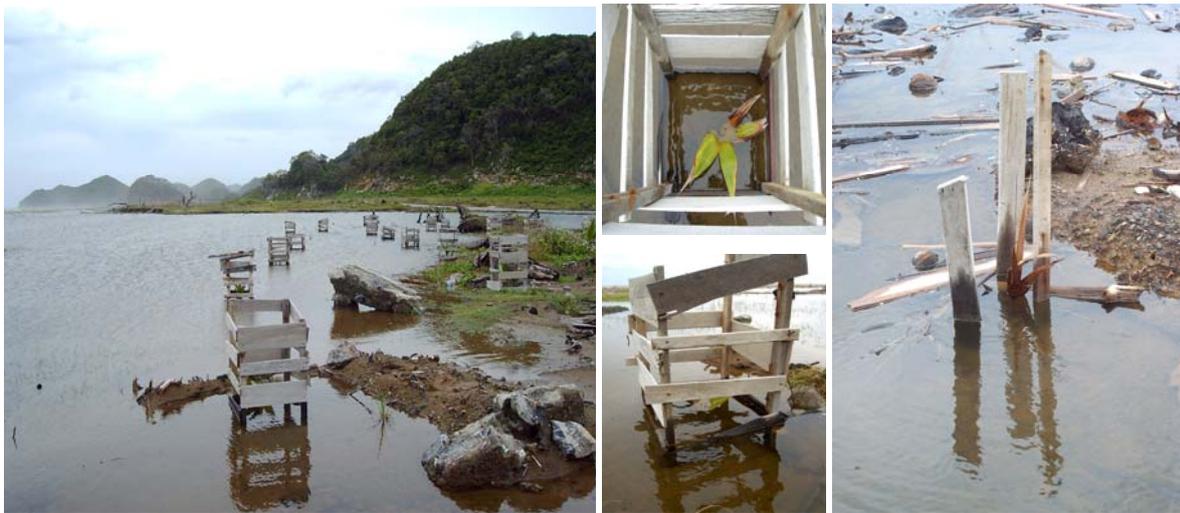
Figure 4-9. Coastal species planted on inundated land

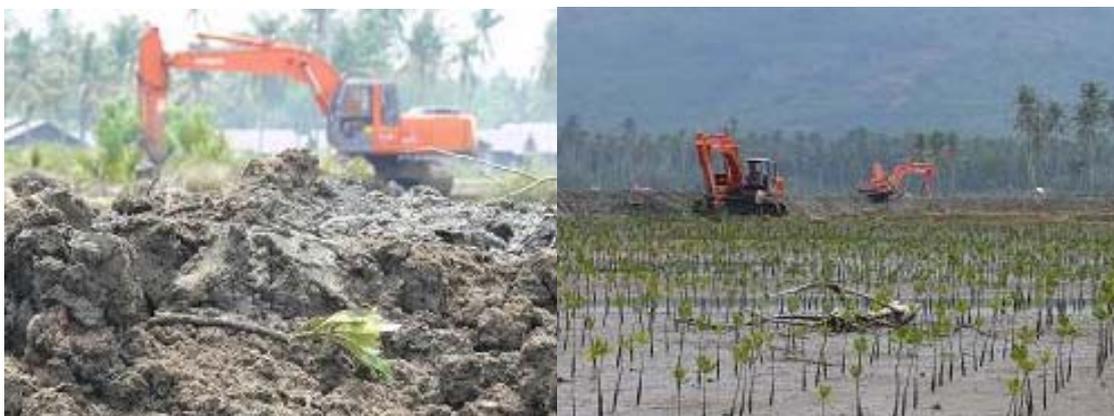
Figure 4-10. Construction of ditches (pond rehabilitation) has damaged the mangrove already planted (Lham Ujong village, Aceh Besar)

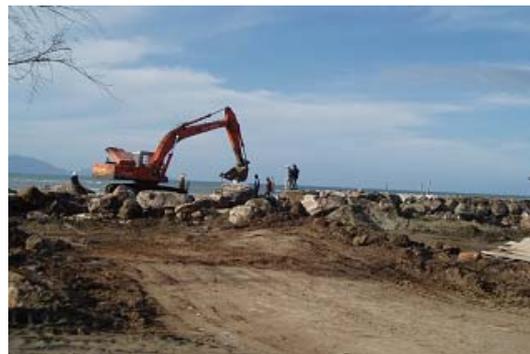
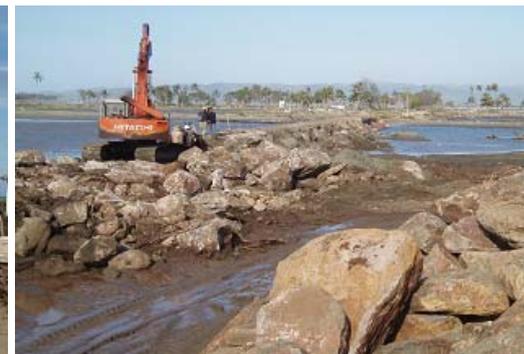
Construction of sea wall in front of aquaculture ponds in Lham Dingin village (Photograph: Suryadiputra, September 2005)

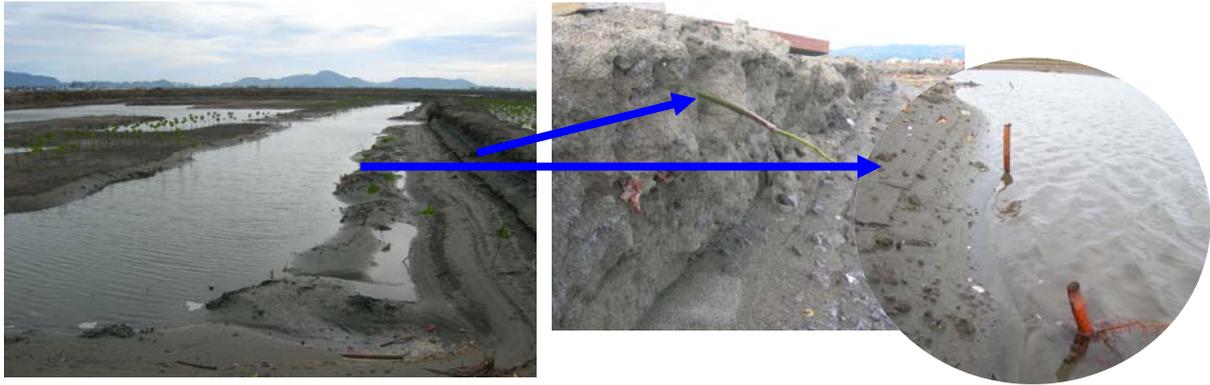
Figure 4-15. Mangroves fall victim to rehabilitation of ponds

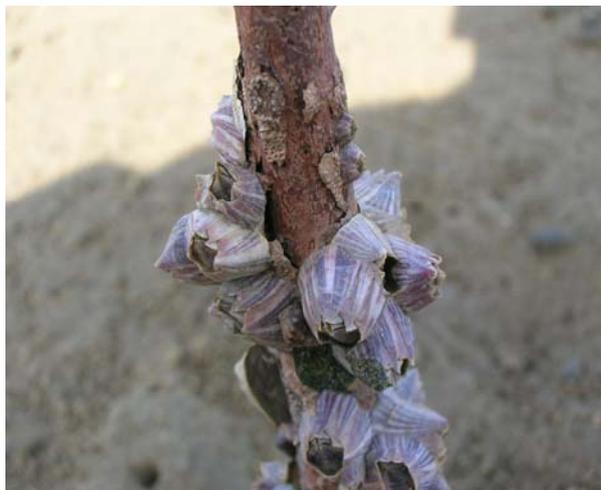
Figure 4-16. Molluscs attacking mangrove

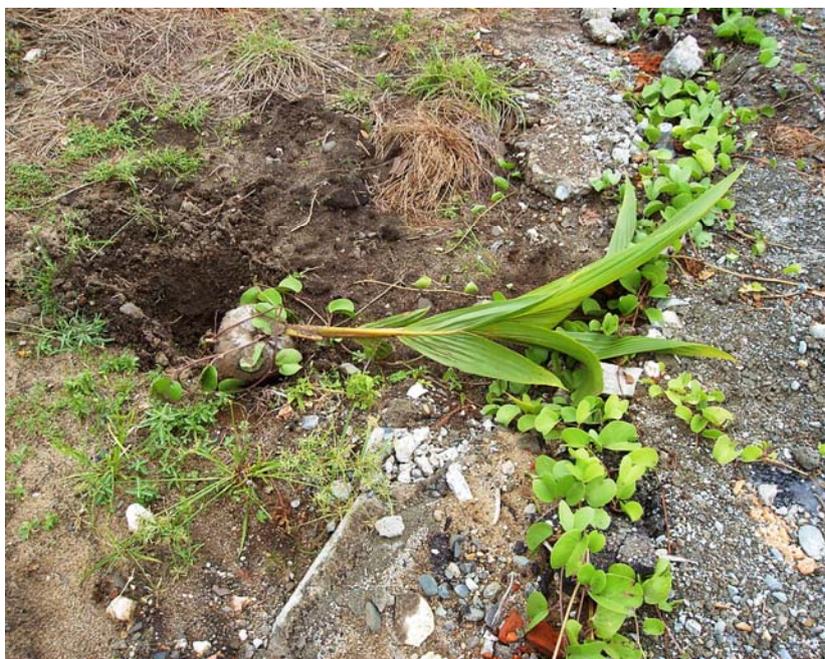
Figure 4-17. Coconut palms devastated by wild boar attack

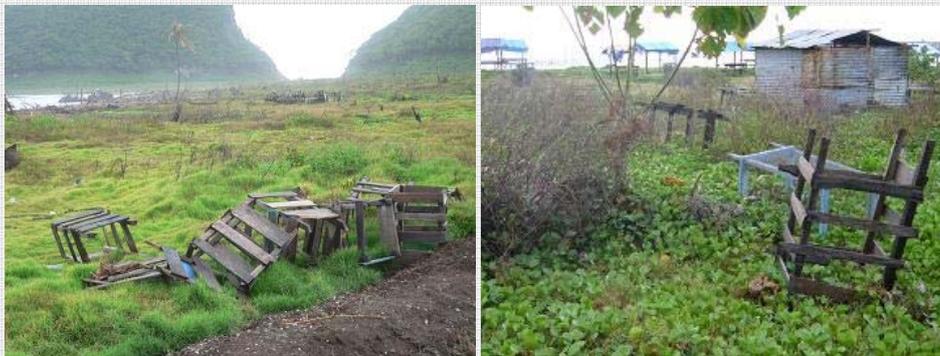
Figure 4-19. Broken, useless and abandoned fences in Lhok Nga

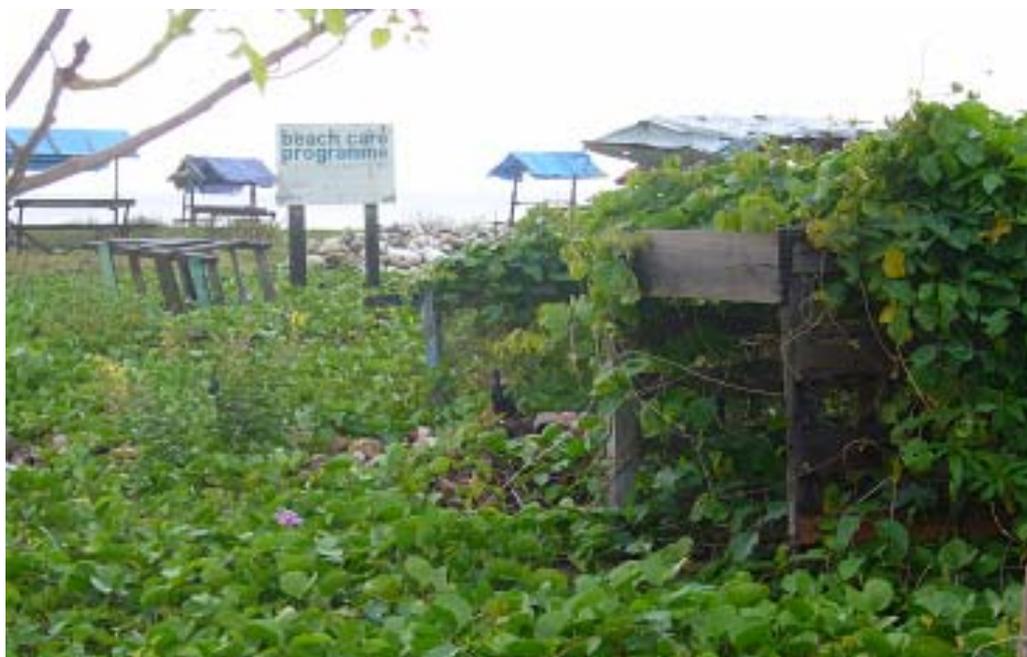
Figure 4-20. Fence swallowed by climbing plants, and seedling eventually dies

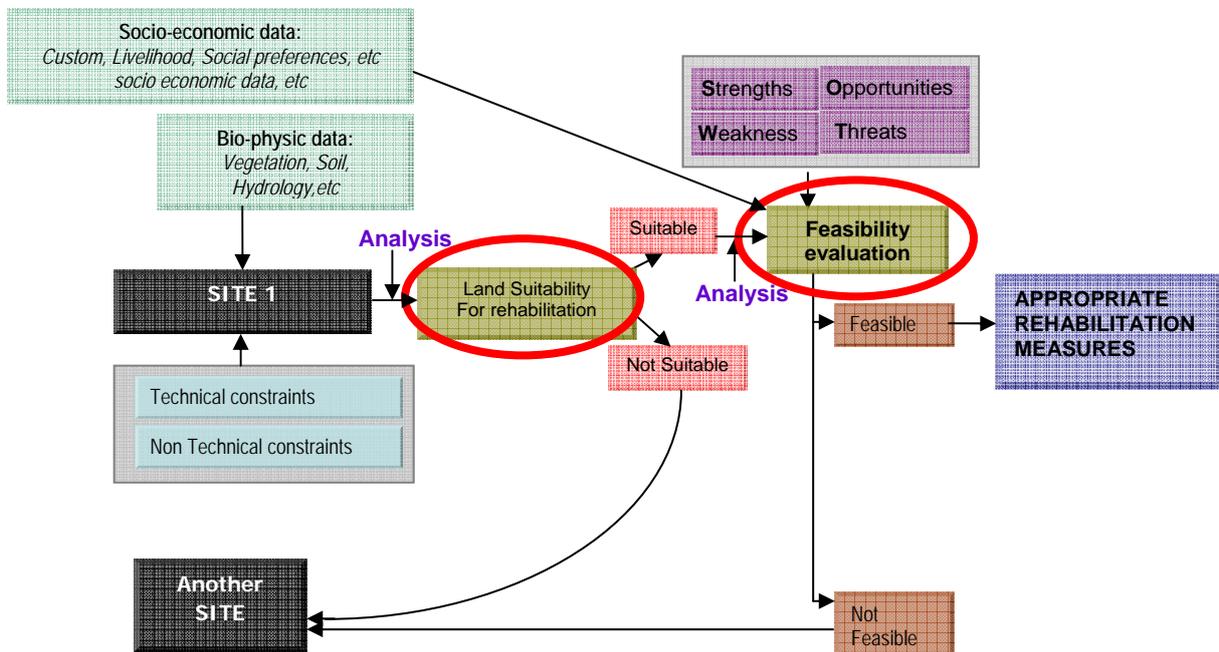
Figure 4-23. DSS flow chart for selecting a rehabilitation site

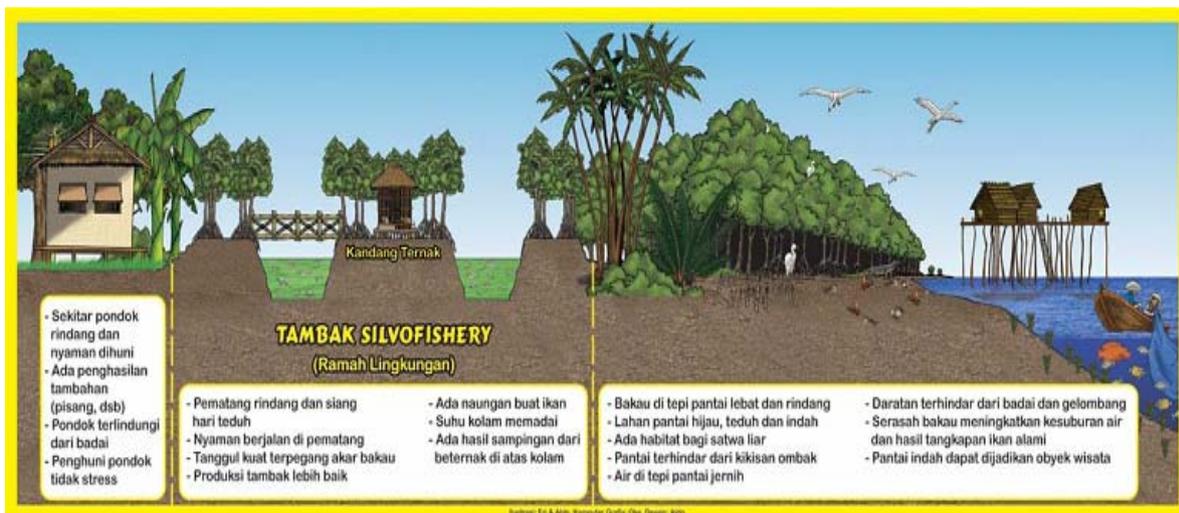
Figure 4-24. A recommended silvo-fishery system: planting mangrove around ponds

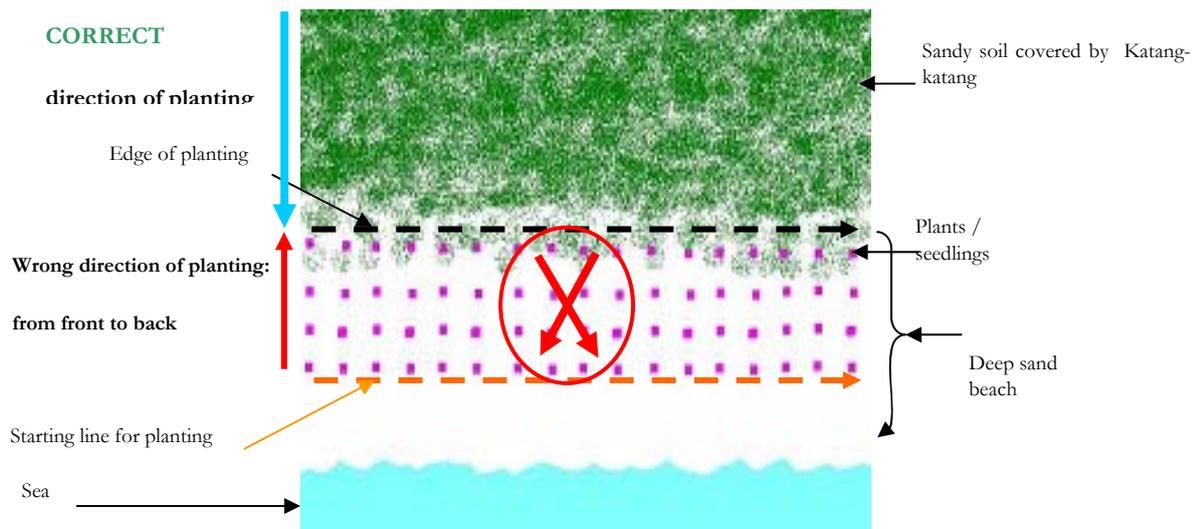
Figure 4-25. Incorrect planting strategy (from front of beach towards back)

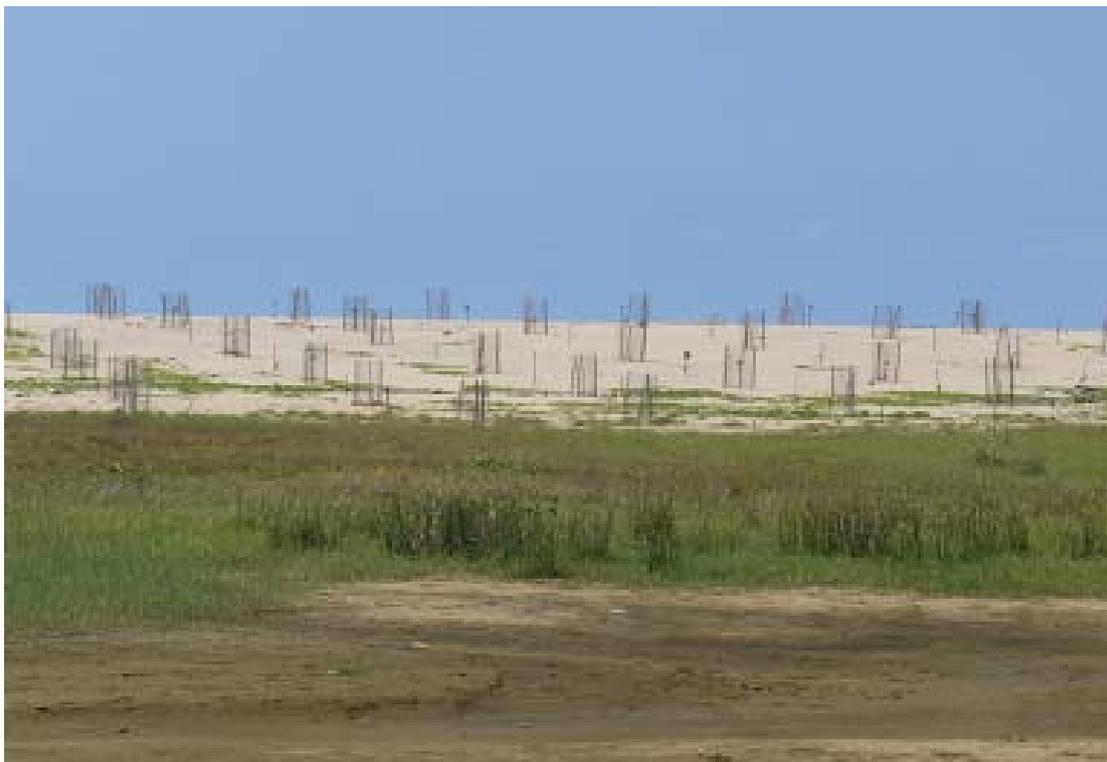
Figure 4-26. Incorrect planting strategy at Lhoong, Aceh Besar (from beach towards land), most of the sea pine seedlings (in wire cages) died from drought
